Kerisel Lecture

The role of Geotechnical Engineers in saving monuments and historic sites.

Calabresi G.

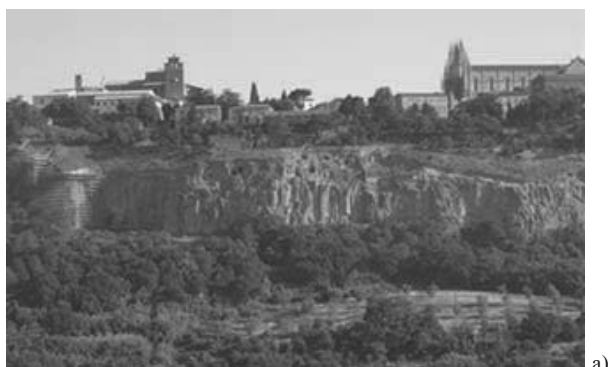
Figure 1. Orvieto: the tuff high cliff (a) consolidated by means of passive anchors, nails and drain pipes (b). Scheme of the strengthening works along the edge of the Rock (Cencetti et al., 2005).

Suffice it to mention the measures taken to protect Orvieto, Italy (Fig. 1), that took more than a decade, with the anchoring of the high cliff faces made of soft pyroclastic rock (tuff) whose stability had been undermined by the slow softening of the Pliocene overconsolidated clays, present at their base (Manfredini et al. 1980, Martinetti 1981, Lembo Fazio et al. 1984, Tommasi et al. 1997, Tommasi and Ribacchi 1997, Pane and Martini 1997, Tommasi et al. 2005, Soccodato et al. 2013)

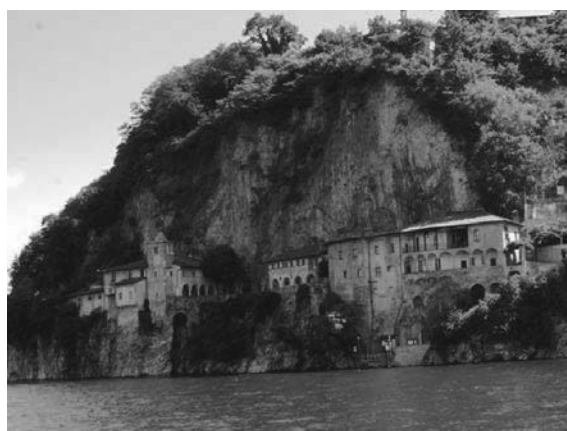
Figure 2. a) The limestone cliff over the hermitage of Santa Caterina del Sasso. b) The anchoring consolidation works.

Not as extensive but not less important are the anchorage works on another cliff face overlooking Lake Maggiore thanks to which the historic hermitage of Santa Caterina del Sasso (Fig. 2) has been saved (Balossi Restelli 2009). More recently, a set of fiberglass tie-rods and a masonry underpinning have stopped the collapse of large tuff blocks from the NW face of the Palatine Hill. This measure not only made it possible to stop the

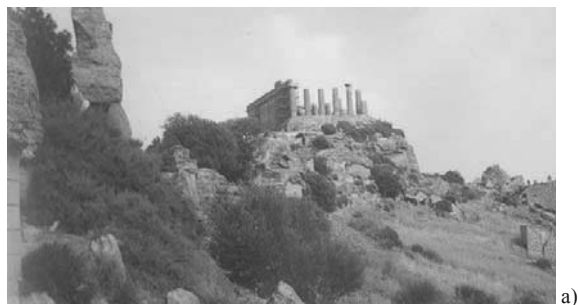
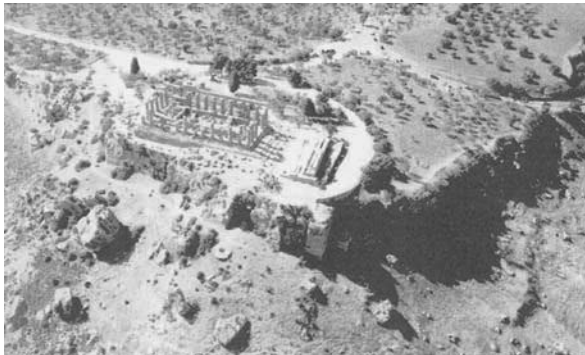
Figure 6. The Temple of Juno at Akragas (Agrigento). a) The calcarenite cliff; b) An aerial view; c) An outline of its foundations (Cotecchia et al. 2000).

The rational layout of the Greek town, Akragas, is only one of the many discoveries made (Fig. 6). Actually it is clear that the designers took into account the geomorphological characteristics of the area and they adopted solutions for the foundations that contemplated the properties of the soils and the seismic nature of the area (Cotecchia 1997, Cotecchia et al. 2000). Indeed, the foundations of the structural elements of all the temples, consisting of large calcarenite blocks were placed on the rigid and resistant calcarenite layer located at several metres depth, underneath the Pliocene outcrop of a medium hard clay: the foundation of the temple of Hera Lacinia is located at more than 7 metres below ground surface. Does this mean that the Greeks knew about the local amplification of seismic action induced by the clay layer? The ruins of Jupiter's Temple, that had been built previously and that had collapsed before its completion, suggest that this may be the case.

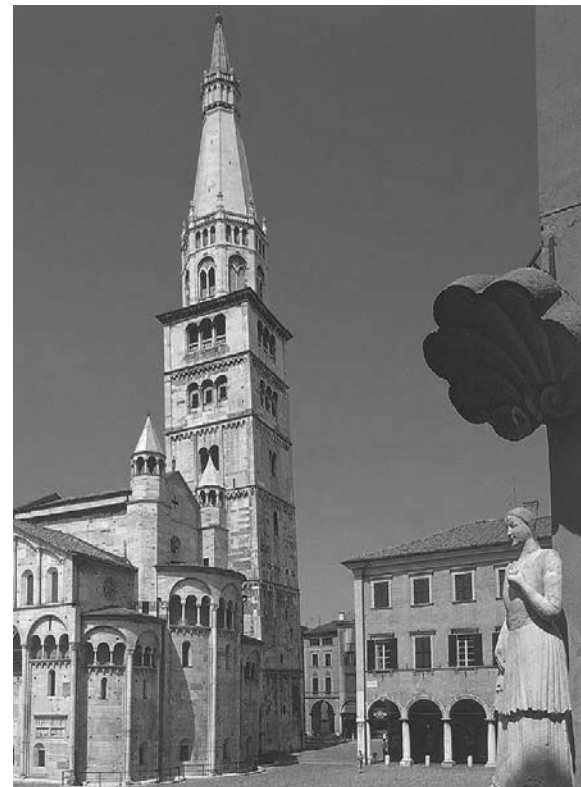
Figure 7. The Cathedral and the Ghirlandina tower at Modena. A view of the leaning tower and the Cathedral apse.

The recent study of the static condition of the leaning tower Ghirlandina in Modena (Figs. 7, 9) is a beautiful, outstanding exemplary demonstration of the importance of deep historic knowledge for explaining the nature and origin of the damages and of the effective contribution offered by a thorough geotechnical investigation. The Ghirlandina, that was designed by Lanfranco, a famous medieval architect, and built from 1099

to 1319, has a total height of 89 m; presently its axis has an inclination of 1°16' against the vertical, that is not increasing. In recent years there has been a widespread concern about the possible seismic vulnerability of the tower and an in-depth research has been carried out on its static and dynamic equilibrium conditions (Lancellotta, 2007, 2013). The main problem was whether the tower had a sufficient stability factor against a seismic action of assumed intensity.

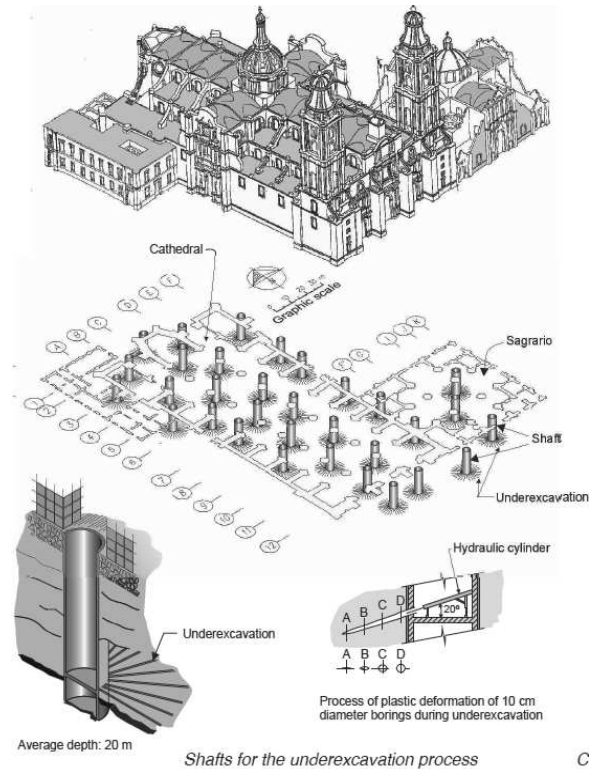
Figure 10. Underexcavation at the Cathedral of Mexico City (Santoyo and Ovando-Shelley, 2000).

In this connection another emblematic and famous case is the Cathedral of Mexico City (Ovando-Shelley et al. 1997, Tamez et al. 1997, Santoyo and Ovando-Shelley 2000, Ovando-Shelley and Santoyo 2001). Historic information made it possible to identify the origin of the differential settlements of the foundation soil, part of which had been consolidated by pre-Columbian works, and to design sub-excavation and soil consolidation measures to offset the differential settlements (Fig. 10). On the other hand, the studies on foundations have contributed to a thorough understanding of the historic events of the Cathedral and of the surrounding area.

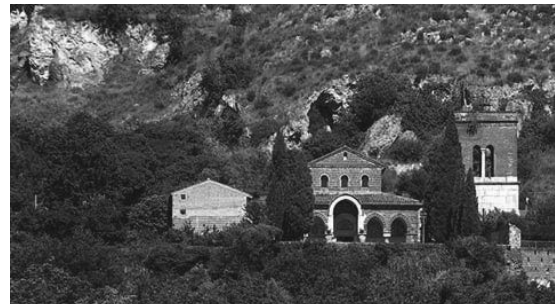
Figure 12. The Benedictine Basilica of St. Angelo in Formis.

St. Angelo in Formis is a Benedictine basilica near Capua which rises on the slopes of a rock hill (Fig. 12); it was built in the 6th century A.D. on the ruins of a Roman temple whose origins date back to the 5th century B.C (Cammarota, 2013). The basilica, which has three naves, presents traces of the changes it underwent in time. In particular the bell tower and the portico probably collapsed and were rebuilt in the 13th century. The foundations of the apse, most of the external walls and the pillars of the naves are rather shallow and rest on a fractured dolomite mass, whereas the foundations of the facade, the portico and a small proportion of the side walls rest on debris deposits and backfill.

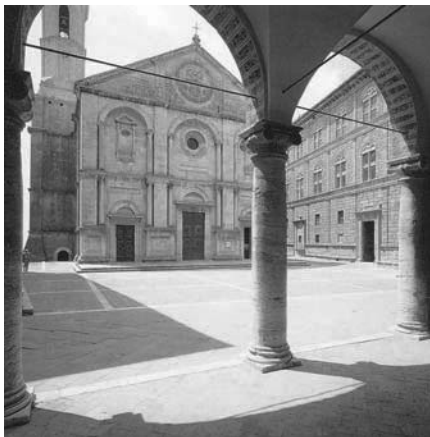
Figure 14. Cathedral of Pienza and Piccolomini Palace from the square.

The Pienza Cathedral (Fig. 14) is perhaps less famous than the Tower of Pisa, but it is just as problematic and intriguing.

Perhaps there is no other monument that, in its lifetime, has been subjected to so many consolidation and strengthening measures as the Pienza Cathedral, because of the very slow, but continuous settlements of the foundation soil underneath its apse (Forlani Conti 1986).

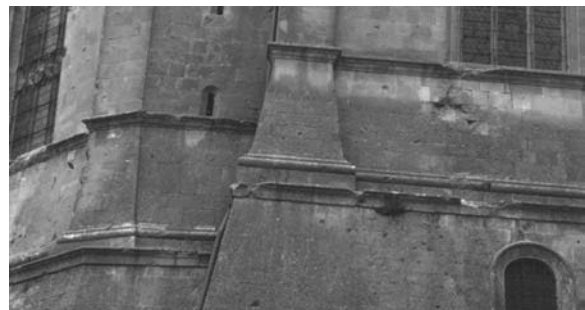
Figure 16. The cornice displacement shows the apse settlement.

All these measures were made necessary by the constant lowering of the apse foundation downhill from the rock scarp: there is proof that between 1520 and 1530 the floor of the apse was already lower than that of the nave by about 27 centimetres. A sudden settlement of about 0.3 m of the soil downhill from the scarp occurred on the night of 26 November 1545 and caused the partial collapse of the apse and of the bell tower. The event, described in the memoirs of a citizen of Pienza is defined *Terrae motus* (literally a movement of the earth), but there are doubts about it being an earthquake or a sudden slope instability phenomenon, perhaps triggered by a seismic quake. At present the overall difference in level of the apse with respect to the nave is about one metre, as it can be seen from the relative displacement of the cornice in Figure 16.

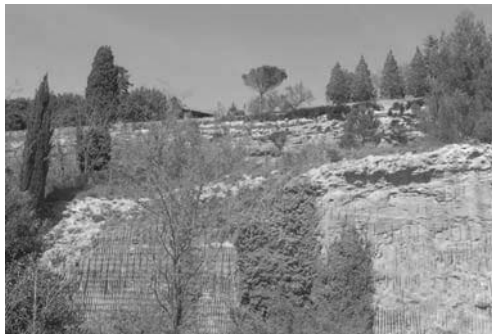
Figure 21. The main fault surface about 400 m N-W of the Cathedral
