2nd Kerisel lecture: Geotechnics and Heritage

2^{me} Conference Kerisel: Géotechnique et Patrimoine Culturel

Carlo Viggiani

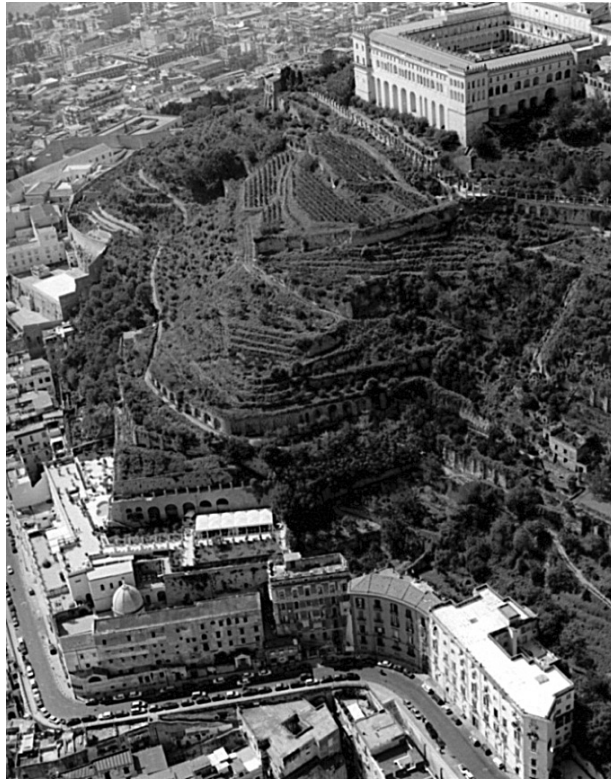
Fig 7. Bird's eye view of the Vineyard, with part of its retaining structures

from an impervious wooded steep crag into a succession of cultivated terraces retained by an impressive system of walls (Fig. 7) and provided with a network of drains, channels and water reservoirs conceived to store rain water for domestic use of the monks and irrigation and to laminate the floods following intense rainstorms (Fig. 8). It is still named “Vigna S. Martino” (S. Martin’s Vineyard).

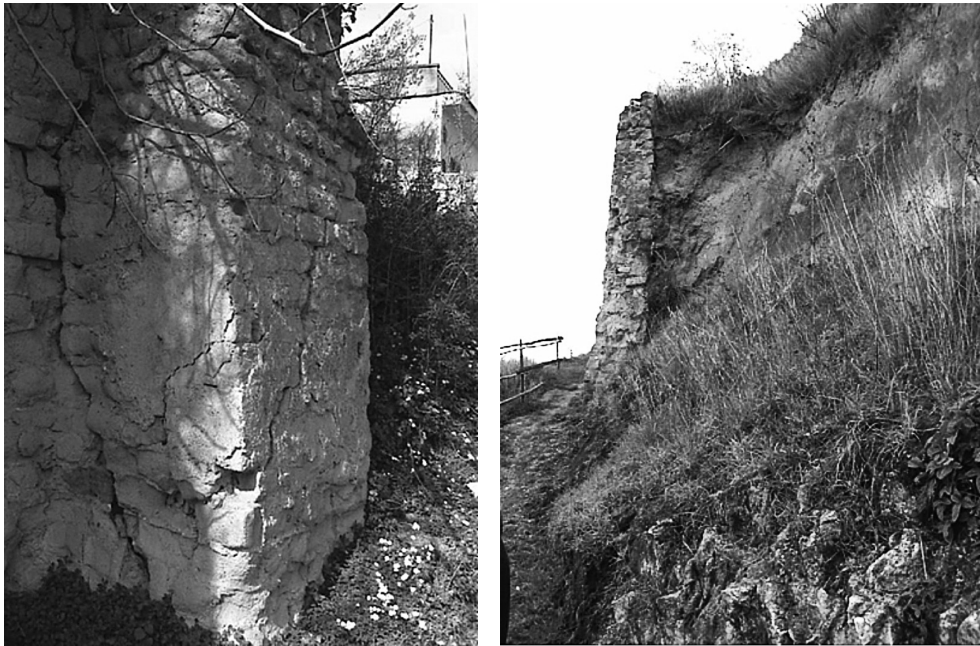
Fig. 9. Examples of deterioration of the system of retaining structures; left: detachment and fracturing of a counterfort; right: collapse of a retaining wall

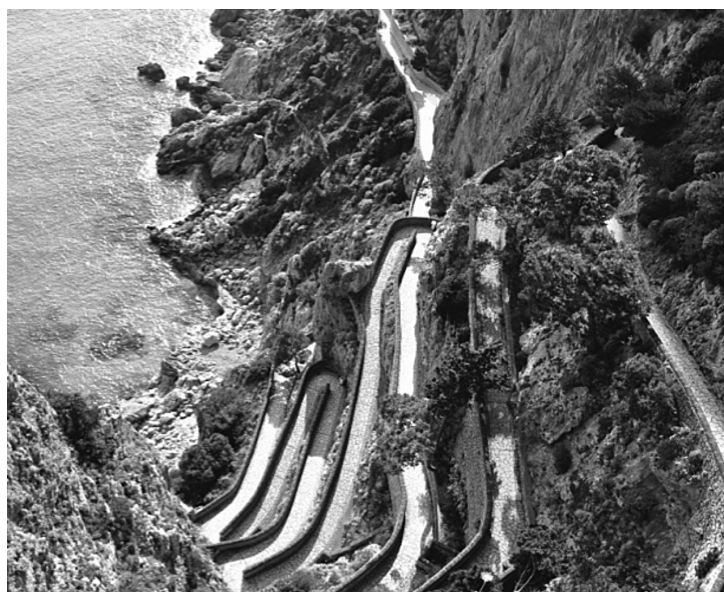
Fig. 12. Capri: via Krupp

Via Krupp (Aversa *et al.*, 1997) is a pedestrian road built in the early XX century on the island of Capri, in the bay of Napoli, to connect the center of the island with the south shore (Fig. 12). According to Pane (1965): “It bears witness that a road can be a work of art, in the aesthetic meaning of these words”.

Since 1927 these operations have been repeated many times, and via Krupp was preserved for a long time. In 1978 it was decided to stop the maintenance program, considered too expensive and not guaranteeing a completely safe use of the road; since then via Krupp has been closed, except for short periods, and only now the Municipality of Capri is considering again the implementation of safety provisions.

A careful investigation including a structural survey of joints in the rock mass by terrestrial photogrammetry and a study of the trajectories of falling blocks leads to the conclusion that the possible protective interventions may consist in the removal of the smaller unstable blocks, anchoring the larger ones and implementing some protective barriers, located after the predicted trajectories of falling blocks and where they can be hidden by the vegetation. In any case, a modern version of the maintenance performed from 1927 up to 1978 with periodical inspections is mandatory.

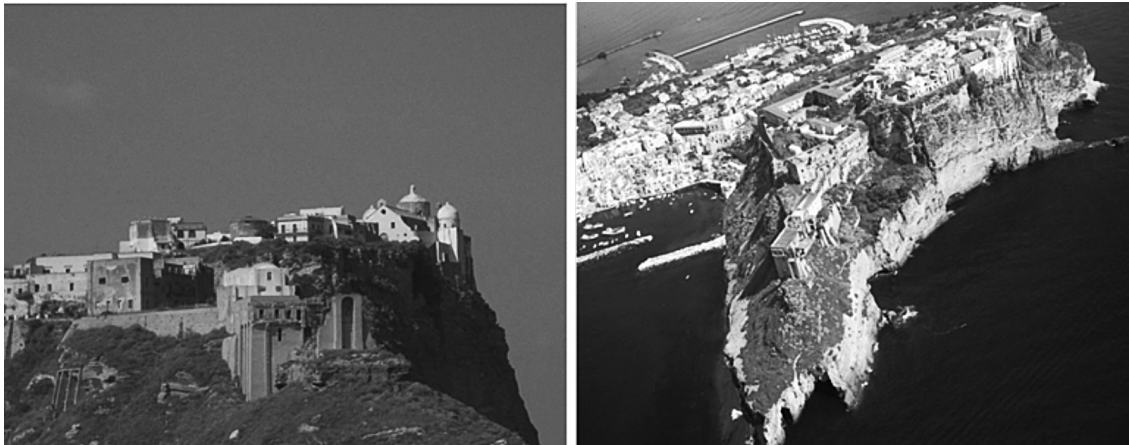
The village of Terra Murata (Walled Land) in the island of Procida, again in the bay of Napoli, is a settlement dating back to the X century and includes the Abbey of S. Michele and a number of other churches. These are exposed to the risk of collapse by the action of the sea, undermining the steep cliffs over which they were erected (Fig. 13). In the forefront of both pictures the remains of the cloister of Santa Margherita Nuova, collapsed due to the sea action in the early XIX century, bear witness of this phenomenon.

Fig. 13. The village of Terra Murata in the island of Procida. (Let) view from the sea; in the background, at the right of the picture, the abbey of S. Michele. (Right) Birds eye view; in the forefront, the ruins of the cloister of S. Margherita Nuova

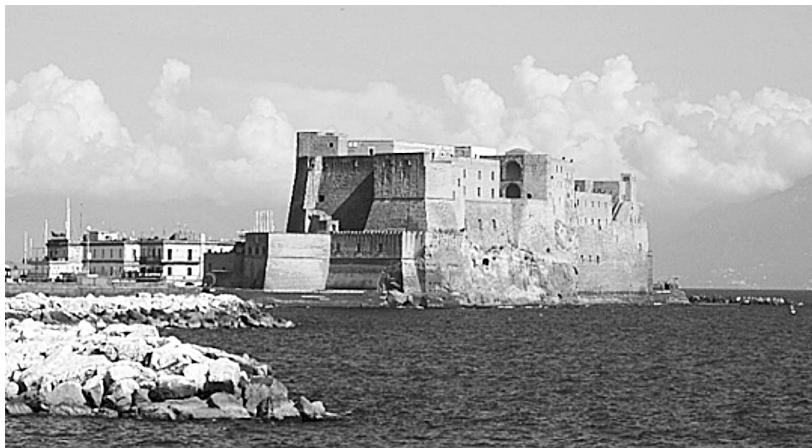
below the castle. Until the egg will not be broken, the castle will stay safe) is one of the outstanding elements of the magnificent bay of Napoli (Fig.14). It stands over a small peninsula of Neapolitan Yellow Tuff, interested by a system of old cavities (in the Middle Ages the seat of a community of Basilian monks) and threatened by a system of fissures protracting in the overlying walls of the castle. The opening of the fissures is continuously monitored by displacement transducers; Fig. 15 reports some results over a period of two years. The influence of the yearly temperature fluctuation is evident, but no long term increase of the openings is evident (Russo, Viggiani, 2000).

Fig. 14. Castel dell'Ovo, Napoli

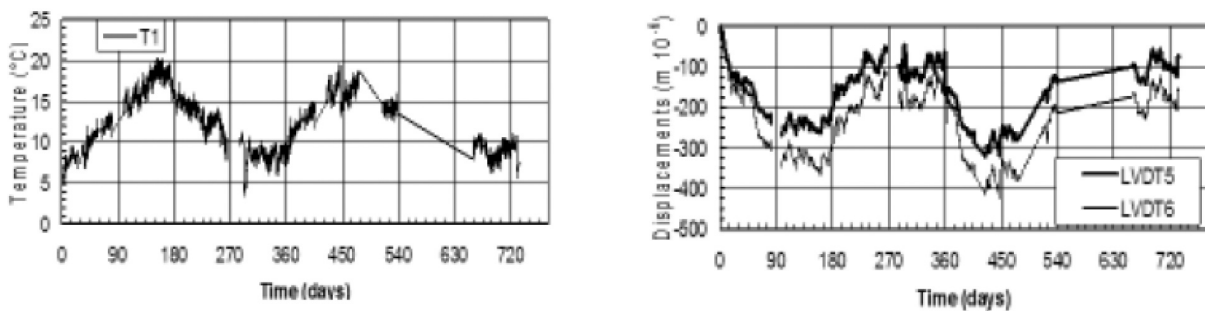
Fig. 15. Opening of fissures in the tuff below Castel dell'Ovo

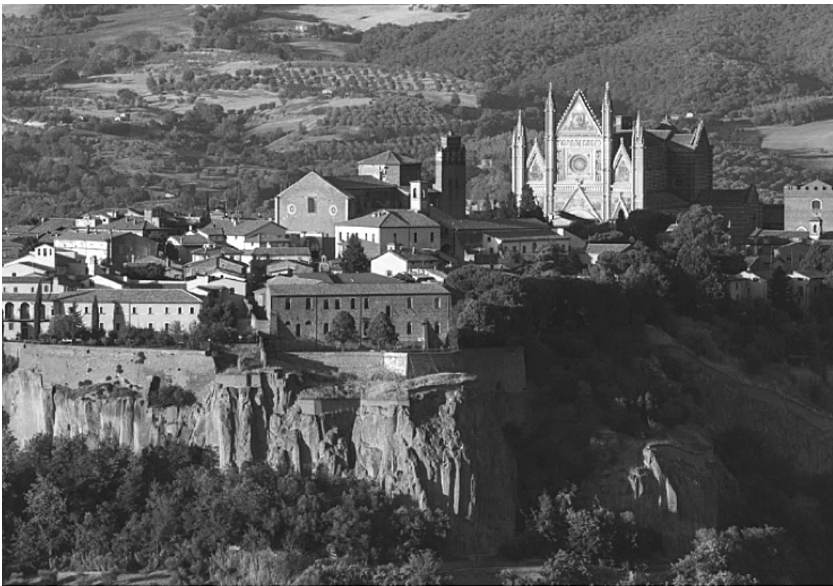
The town of Orvieto (Fig. 16), in the upper Tiber valley, rises on the top of a mesa formed by a slab of volcanic tuff overlying an overconsolidated clay formation (Tommasi *et al.*, 2013). The flat topped hill delimited by steep escarpments favoured human settlement. The town originated as an Etruscan centre in the IX century BC, was destroyed by Rome in 264 BC, but grew again in the Middle Age to a population of 20,000 inhabitants. Major buildings, infrastructures and churches were built during that period, including the Cathedral (Fig. 17), one of the masterpieces of medieval architecture in Italy.

Fig. 16. Orvieto

The town is at present interested by a broad program of protective interventions; some of the provisions adopted are reported by Calabresi (2013). Monitoring indicates that the clay slope, in various areas of the hill, is still experiencing slow shallow and deep movements, which can be at the origin of new instability phenomena with significant damage potential to buildings and infrastructures. It is to point out that the situation of Orvieto is far from unique in Italy; similar problems affect for example other cities of the Tiber valley, as Civita di Bagnoregio, and of the Basento river valley as for instance Pisticci.

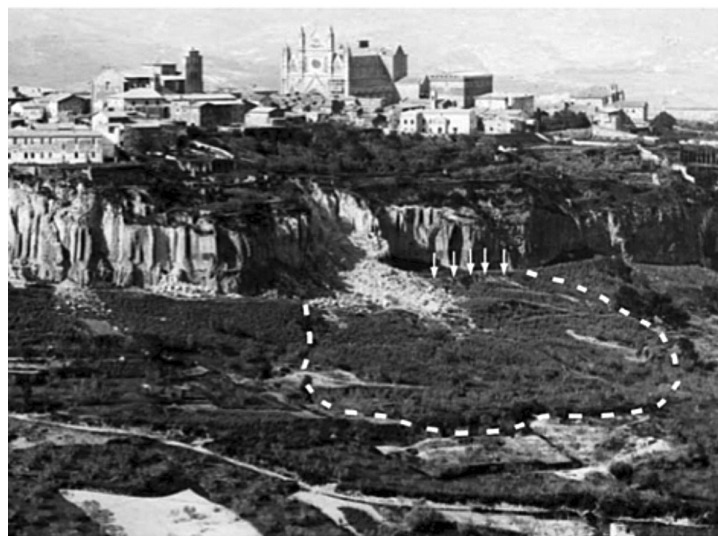
Fig. 18. Orvieto; the collapse of a sector of the tuff slab in 1898. The arrows and the dashed line indicate respectively the crown scarp and the body of the previous landslide on the clay slope.

cliffs, often connected to landslides in the underlying clays, are reported since the XIII century; one of them, occurred in 1898, is shown in fig. 18.

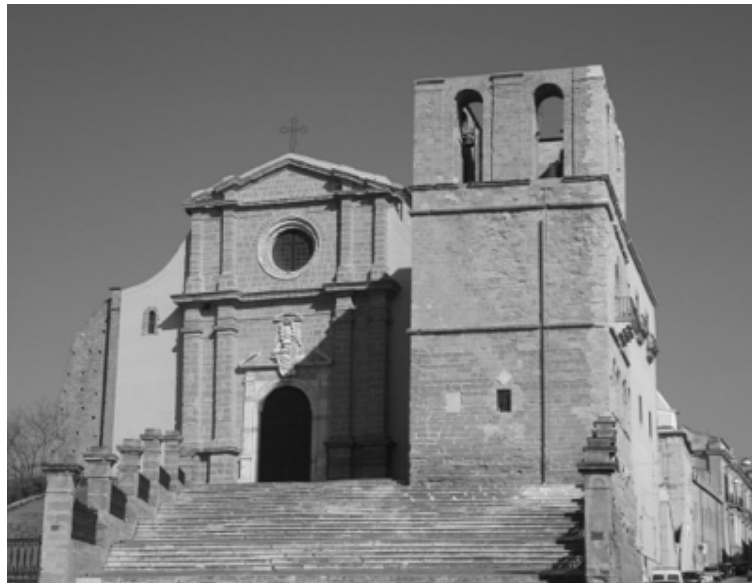
The gothic Cathedral of Agrigento, in Sicily (Fig. 19, Valore, Zicarelli, 2013), was built in the XI century on the top of a hill, right on the edge of a steep slope 40 m high and with an inclination of 40° to 50° over horizontal. It has been repeatedly transformed in XIV, XVI and XVII centuries as a consequence of structural damages caused by differential settlement and seismic actions. Baroque superfetation has been added in XV century and partially removed in XX century. A massive still unfinished bell tower was added in XX century. The behaviour of the cathedral has never been satisfactory; settlement, tilt, distortions, partial collapses have occurred. Many interventions, including partial demolition and reconstruction,

Fig. 19. The Agrigento Cathedral

have been carried out in the last century. The most notable one was a massive underpinning by means of micropiles in 1976-1980. All these interventions have been unsuccessful and sometimes even detrimental; the cracks pattern observed after each intervention was a replica of the previous one. In 2010, a few years after the last intervention, the Cathedral had to be closed. Recent geotechnical investigations have identified a large sliding mechanism of the underlying slope, involving the North aisle of the Cathedral and the adjacent stretches of the edge of the slope (Fig.20). It is now evident that the preservation of the Cathedral requires the stabilization of the slope.

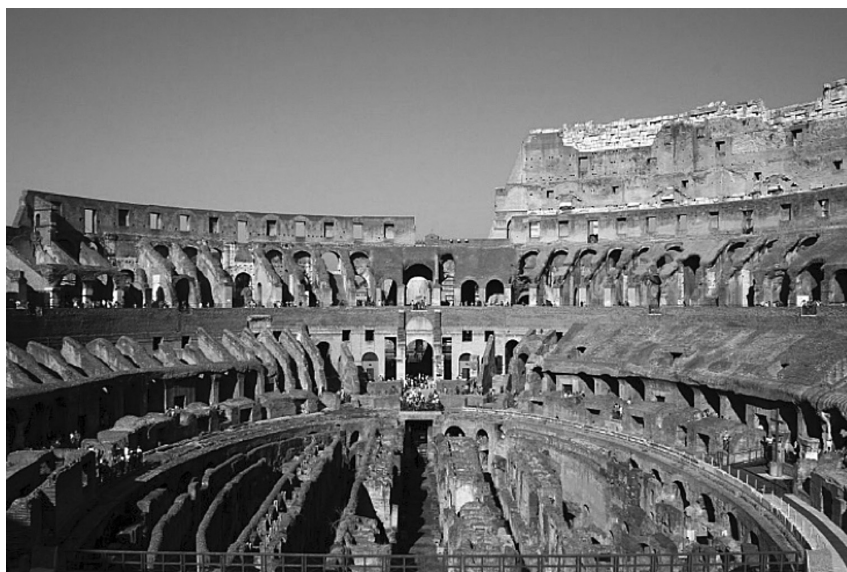
covering an elaborated underground structure called Hypogeum (Fig. 22), consisting of a two-levels network of tunnels and cages where the gladiators and animals were held before the contest.

Fig. 22. *The Hypogeum*

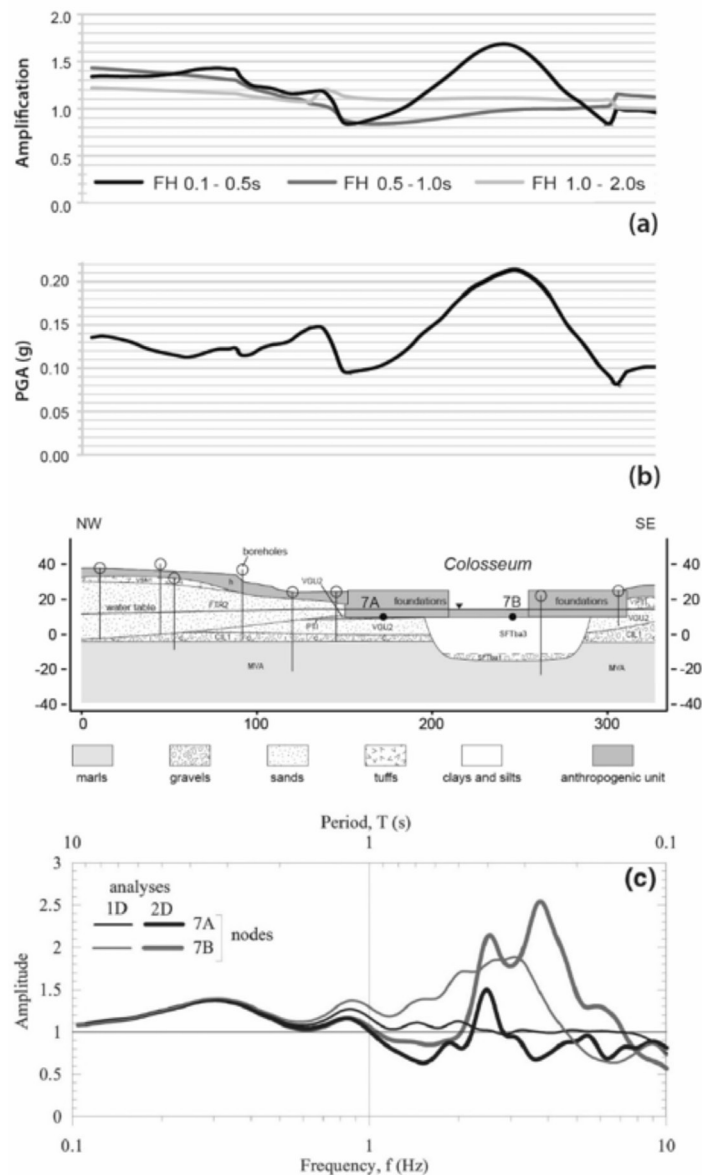
Fig. 25. The subsoil of the Colosseum: (a) Housner intensity amplification factors FH, (b) peak ground acceleration PGA, (c) amplification functions in selected surface nodes computed for cross-section #7 (modified after Pagliaroli et al. 2014).

Legend of geological cross-section: MVA, Monte Vaticano Formation; CIL1, Santa Cecilia Formation; VGU2, Valle Giulia Formation; PTI, Palatino Unit; FTR2, Fosso del Torrino Formation; VSNI, Villa Senni Unit; SFTba, Tiber River Syntem: Alluvial deposits; h, anthropogenic unit.

contrast of impedance have been responsible for the southern part of the monuments suffering severe damages and partial collapses (Fig. 25). More detailed investigations have been planned to further clarify

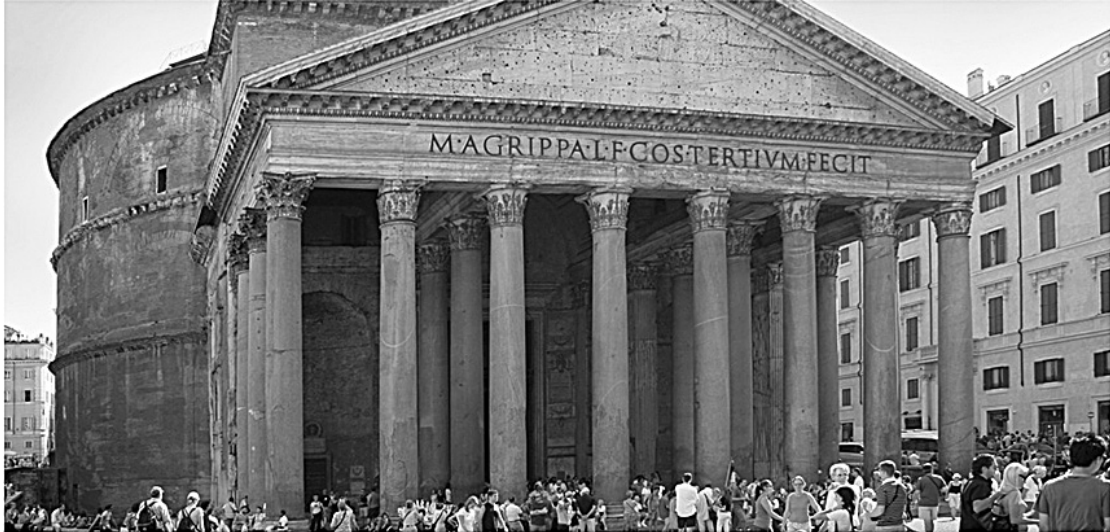
this item, that could even be significant for the safety of visitors. The Pantheon (Belardi, 2006) is a circular building (*rotunda*) covered by a hemispherical dome, with a porch with large granite columns connected to the rotunda by a rectangular vestibule (fig. 26). The dome, with a central opening (*oculum*) to the sky, two thousand years after its construction is still the largest existing unreinforced concrete dome with its 43.3 m inner diameter. In spite of its simple geometry with a cylindrical wall and a hemispherical dome, the structure of the building is very complex. The wall is actually composed by 16 pillars connected to the dome by a system of barrel vaults and relieving arches (fig. 27). Fissures and damages to the structure have been recognized

Fig. 26. The Pantheon today

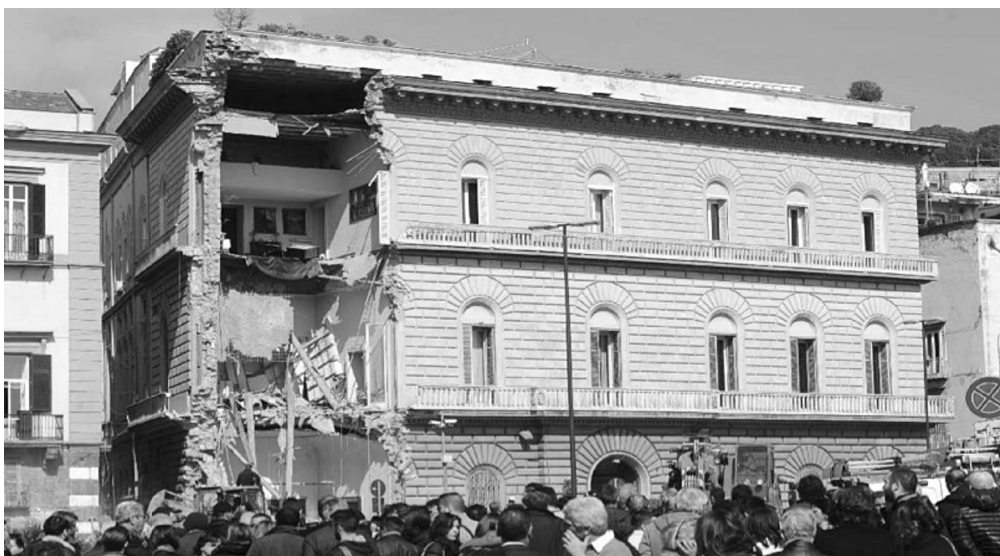
Fig. 30. The collapse of the western corner of the Guevara di Bovino Palace, Napoli

The Guevara di Bovino palace in Napoli is a rich mansion in Renaissance style, dating back to the early XIX century. In March 2013 the western corner of the palace collapsed (Fig. 30), due to an accident occurred during the excavation of a nearby station of Line 6 of Napoli Underground.
