# Taking care of heritage, a challenge for geotechnical engineers

Alessandro Flora

*University of Napoli Federico II, Italy*

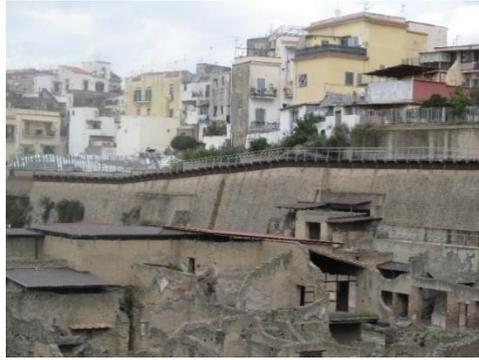
Figure 4. The Greek-Roman town of Ercolano (Italy), still partly buried under low quality modern buildings.

A paradigmatic example of built heritage not visible by ignorance is a part of Ercolano, a Greek-Roman town buried by the eruption of Mount Vesuvius in AD 79. Clearly, part of the town (how large? How relevant?) is still buried under modern buildings (Fig. 4), built with no respect - ignorance, in its literal meaning - of the underground heritage constraints.

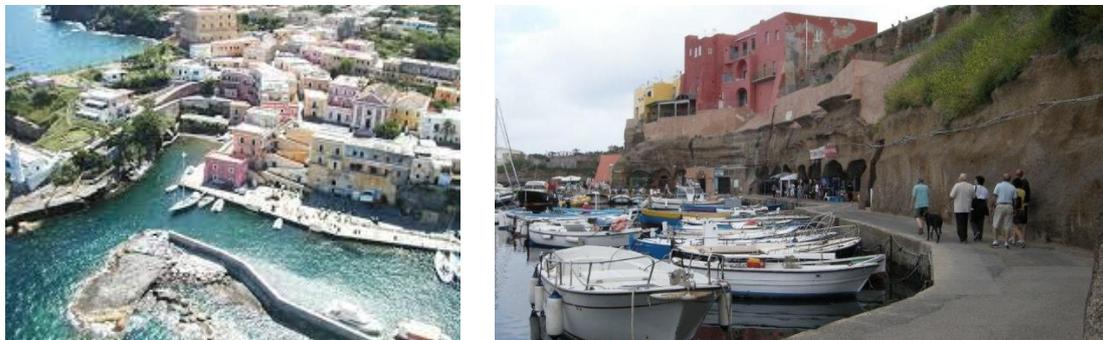
Figure 7. The Roman port of Ventotene (one of the Pontine islands, Italy), still in use (thus at the highest possible level of functional integrity), was entirely excavated in the rock bank, removing some 60.000 m<sup>3</sup> of material, to support emperor Augustus' (63 BC – AD 14) summer residence, as there was no natural harbour on the island.

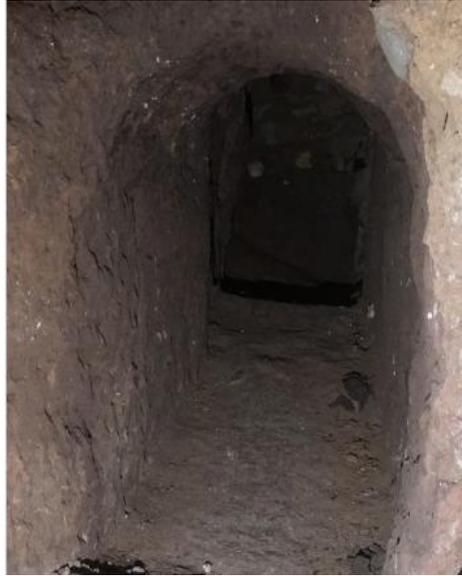
Figure 16. Unlined stretch of a tunnel excavated in the *tierra café oscuro* (modified after Lacombe *et al.*, 2020).

The unlined tunnels in the *tierra café oscuro* layer have a typically stable arched vault (Fig. 16), while the lined ones are vaulted on the top with a triangular corbelled arch. In most lined tunnels the lower walls are slanted. Section T4 is rather irregular and the final shape identified in the figure is just a rough approximation. The dimensions vary within each type but, in general, tunnels are small, serving as pathways for the archeologists, with an average width of about 1.0 m and a height ranging from 2.0 m to 3.0 m. Tab. 1 provides the statistical information obtained from the 3D survey. The distance between tunnels and external surfaces is represented in Fig. 15 by the minimum distance  $R_{\min}$ . This is measured from the axis at the base of the tunnel to the nearest ground surface.

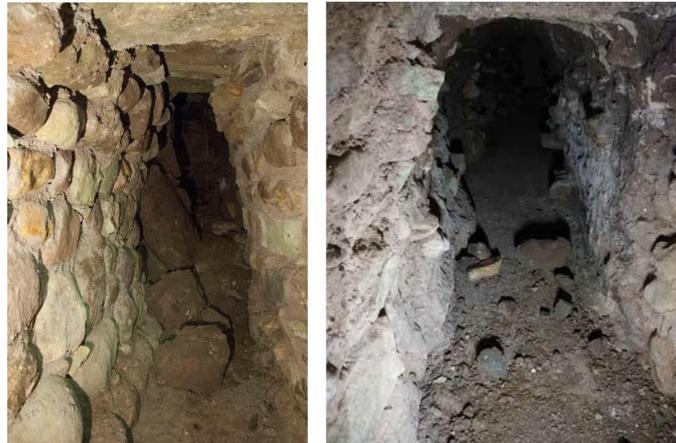
Figure 17. Examples of local collapses: (left) at the interface between lined and unlined stretches; (right) in an unlined tunnel excavated in fine yellow sand (*girín*) (modified after Lacombe *et al.*, 2020).

The full length of the tunnels and the range of distance to the outside surface are summarized in Table 2. Here the surface is classified as sloped or horizontal. The slope of the stepped external surfaces of the pyramid-like structures is about 45°. In total, 360 m of tunnels can be found under the Hieroglyphic Stairway Temple. About 50% of these tunnels have a T3 section, while the other three types of section are equally distributed, as shown in Tab. 2. Most times, collapses occurred at the interface between lined and unlined tunnels or in unlined tunnels, as shown in the photos of Fig. 17.

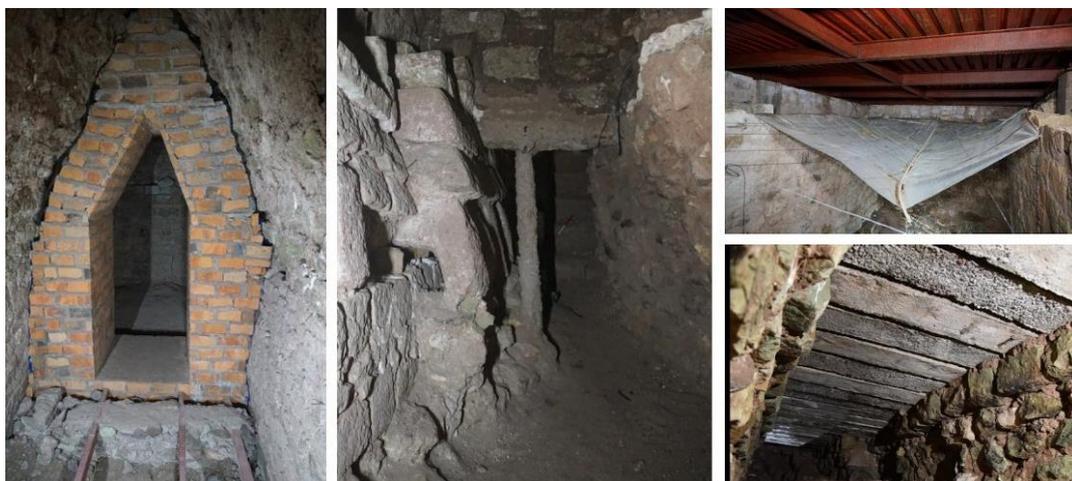
Figure 18. Different kinds of local stabilisation interventions (modified after Lacombe *et al.*, 2020).

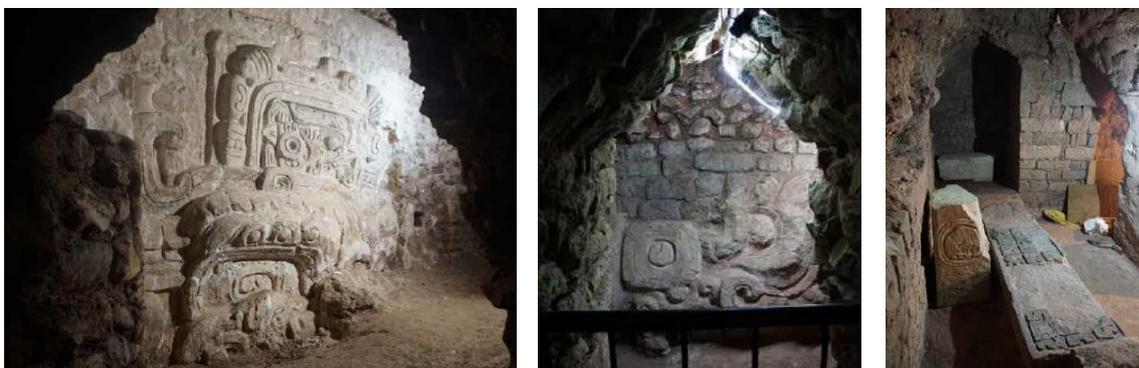
Figure 23. Examples of parts of the buried Maya structures discovered in Copan through archaeological tunnelling (modified after Lacombe *et al.*, 2020).

From a strategic point of view, the preservation of the invaluable heritage existing deep inside the Copan Acropolis (Fig. 23) would ask for a massive application of these preservation actions.

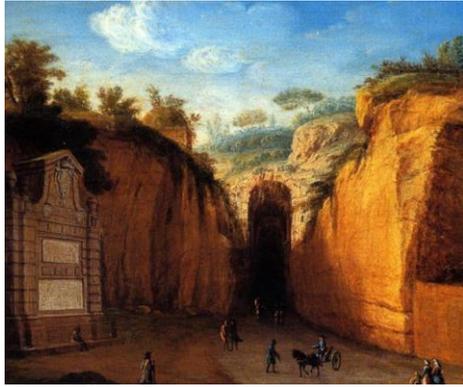
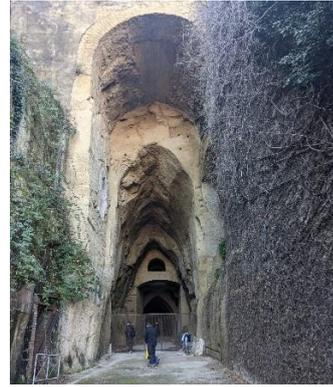
Figure 28. Eastern entrance of the Crypta Neapolitana in a painting (van Wittel, XVIII century, oil on copper) and in a recent photo.

Figs 27 and 28 show the two entrances of the tunnel. Recently, bolted steel arches were placed to support the vault in the first 30- 40 m on the western side (Fig. 27).

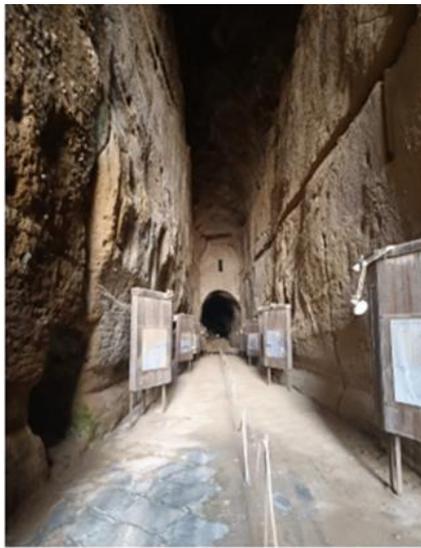
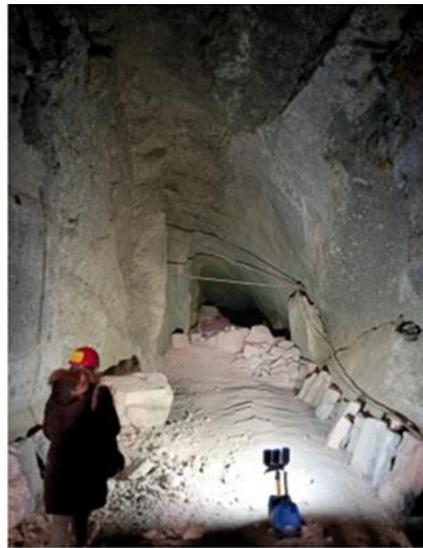
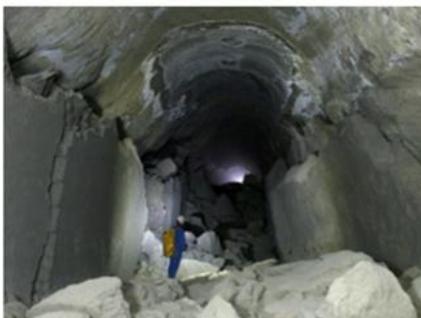
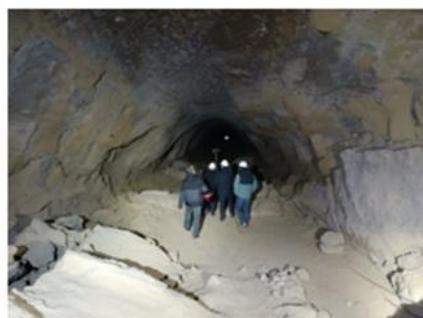
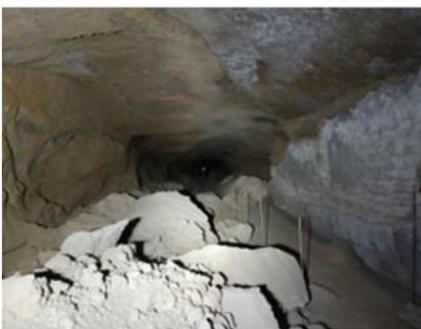
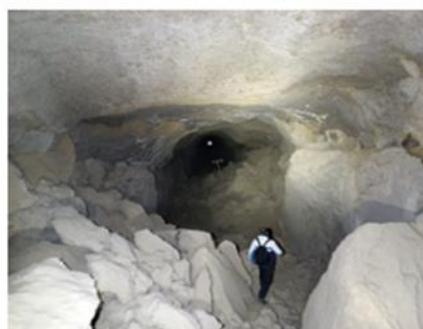
Figure 29. From top left: pictures from the western entrance till ca. progressive 350 m. Collapse of blocks, tension cracks and collapse of masonry lining are clearly visible;

The tunnel is actually in very bad static conditions, with diffused collapse of large blocks along its axis, especially in the central part, where site survey is now almost impossible for safety reasons. The Roman masonry lining has collapsed along the whole lined stretch, with only few parts, with no static role, still standing. A large part of the masonry supporting structures placed in the 19th century collapsed. Figs. 29 and 30 show some photos of a recent survey (January 2022) from both entrances of the tunnel, giving a clear idea of the widespread state of instability.

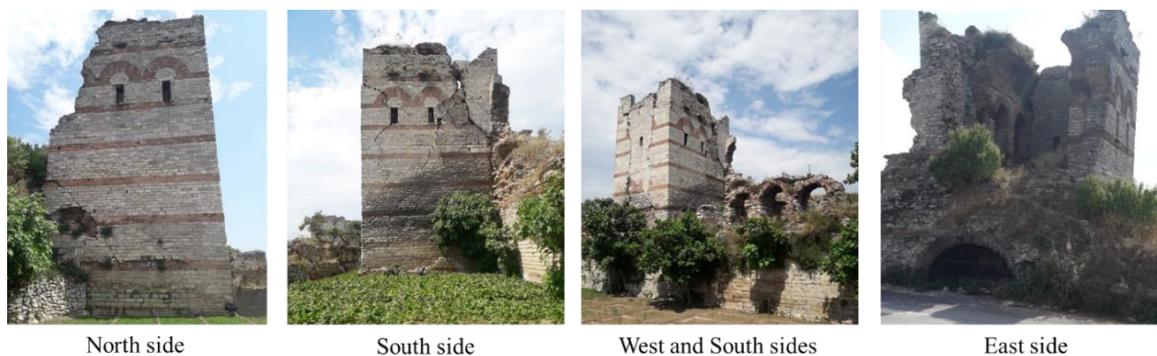
Figure 40. Recent views of all sides of tower 19. The damages caused by 1999 Kocaeli earthquake are clearly visible.
